TECHNICAL SERVICE BULLETIN

No.LTB00052/2007

Subject/Concern:	Freelander - Fuel Pressure Sensor Repair Harness
Model:	
Freelander (LN)	Year: 2001 Onwards Engine: Td4

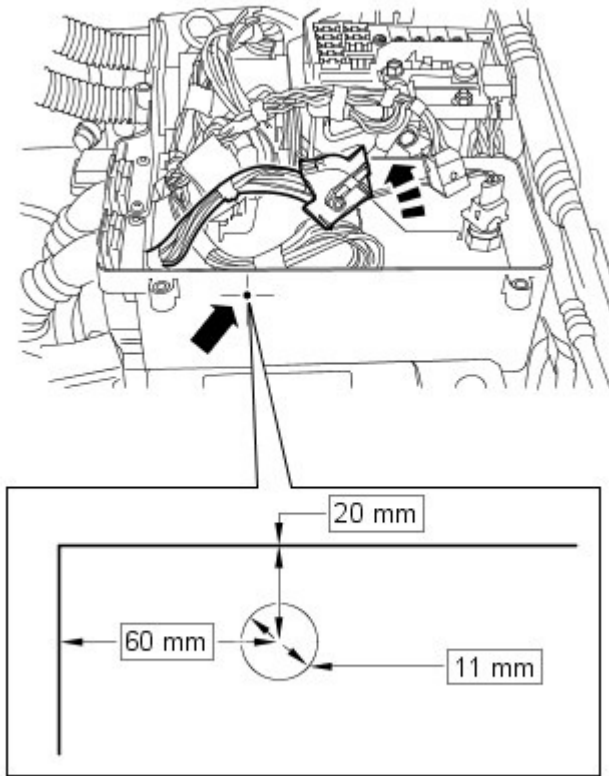
E85072

4. Drill an 11 mm hole in the side of the E-Box at the position shown.

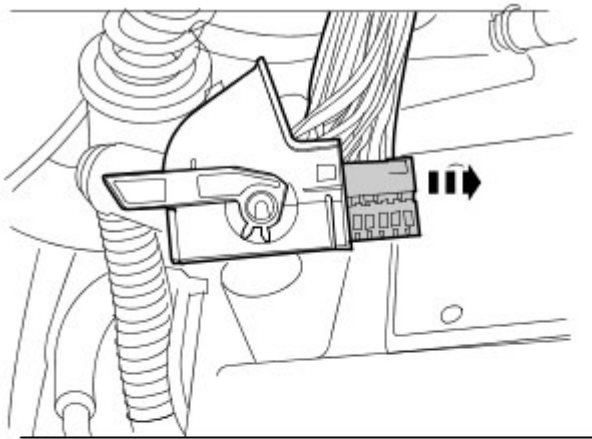
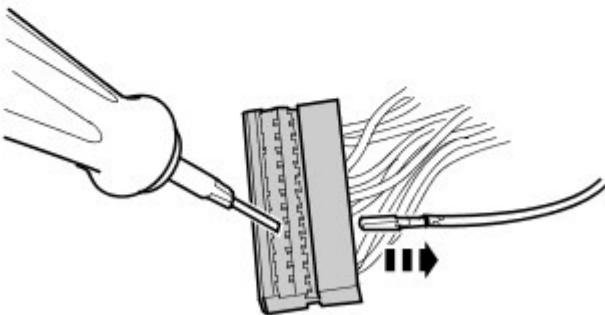
E85073

5. Pass the new overlay harness wires through the hole into the E-box.
6. Release the terminal pins from the control module connector individually, cut away the redundant connector and connect the new terminals:
 1. Pin 35 - white/yellow (WY).
 2. Pin 20 - brown/green (NG).
 3. Pin 33 - blue/black (UB).

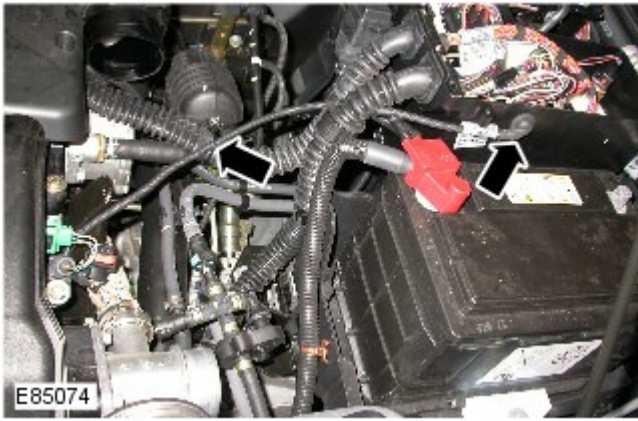
7. Secure the redundant connector wires to the wiring harness using

a suitable electrical tape.

- 8. ⚠ Ensure the grommet is correctly installed to prevent water/moisture ingress.**

Secure the overlay harness, following the route of the old harness, using cable ties.
