## JACK SHAFT

### Triumph Stag

Part Number: **214789**

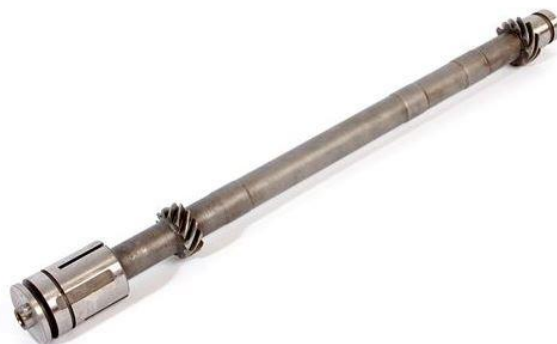
Why are you replacing your jackshaft? If it is because of worn gears, then this may be of interest to you.

The most common cause of jackshaft failure is a worn engine block as this can cause low oil feed to the water pump drive gear.

It is imperative that on removal of the old jackshaft the engine block is accurately measured to see whether the wear falls within the tolerance laid down by the manufacturer.

If excessive wear is found the engine block should be machined and bushed accordingly. Failure to do this will result in terminal damage to the engine.
